Manhole Inspection Summary

Manhole # S29G__052MH

Insp Date: **1/26/09 12:27 PM**

Location Address: **Fairmount Av**

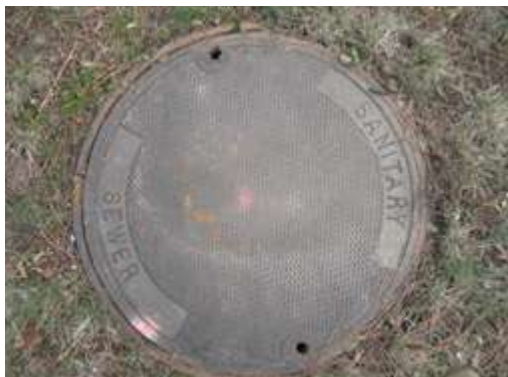
Miscellaneous

cover pic

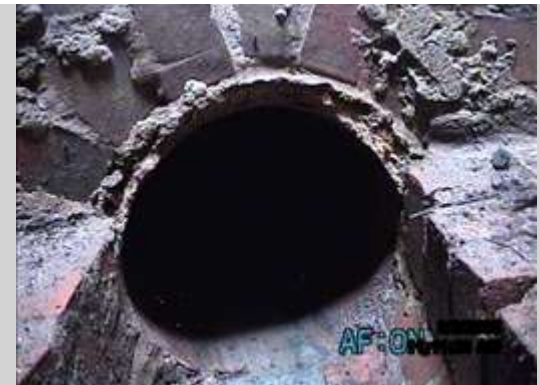
4 O'Clock Inflow

10 in. Circular Gravity Sewer
Pipe In @ 4 O'Clock

Pipe Height: **10.8** (in.) Rod and Bar (Angled)
Pipe Material: **Clay** ☐ Pipe Lined
Invert Depth: **10.82** (ft.) Flow Characteristics: **Slow**
Deposits: ☒ None ☐ Mud ☐ Sludge ☐ Debris ☐ Grease
Silt Depth: **0** (in.) Deposits Extent:
Infiltration: **None** Pipe Seal Cond: **Sound**
